Reserve Fund Study

Hawkestone Yacht Club

**215 Mill Street
Hawkestone, Ontario**

June 29, 2016

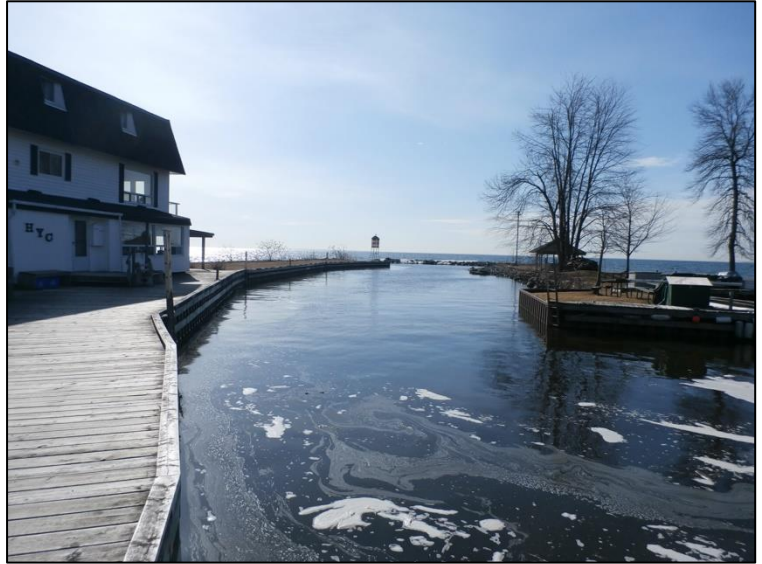
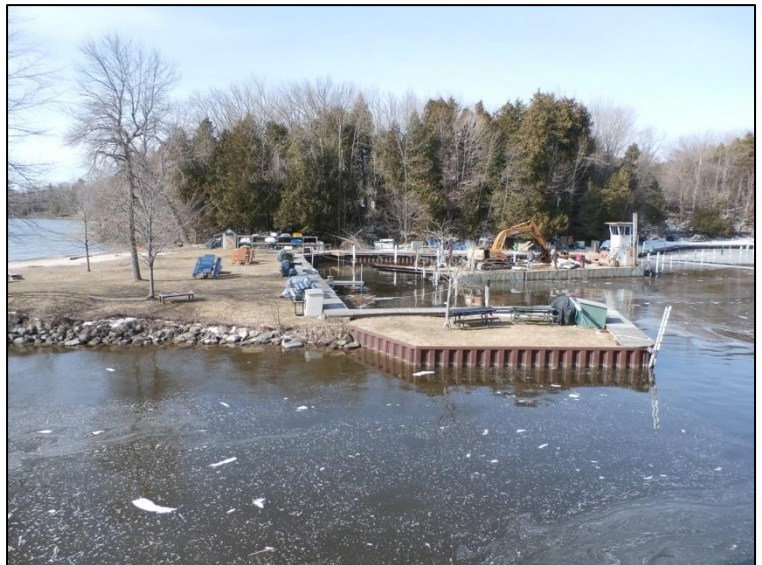
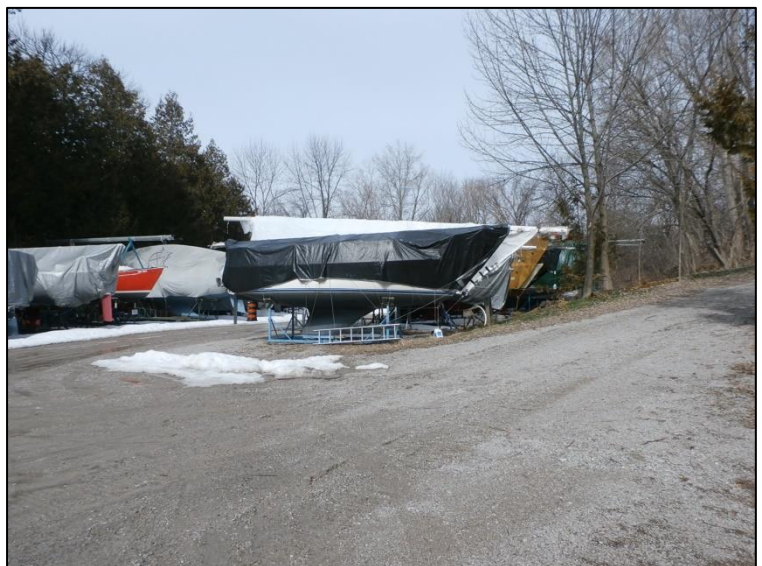
Images No. 1 to 3

General overview of the site

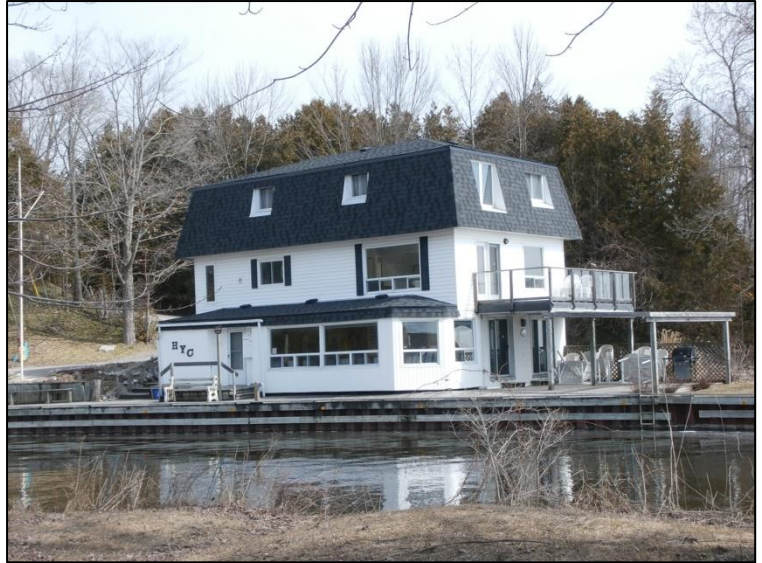
Image No. 4

The site's house that operates as a clubhouse and residential apartment

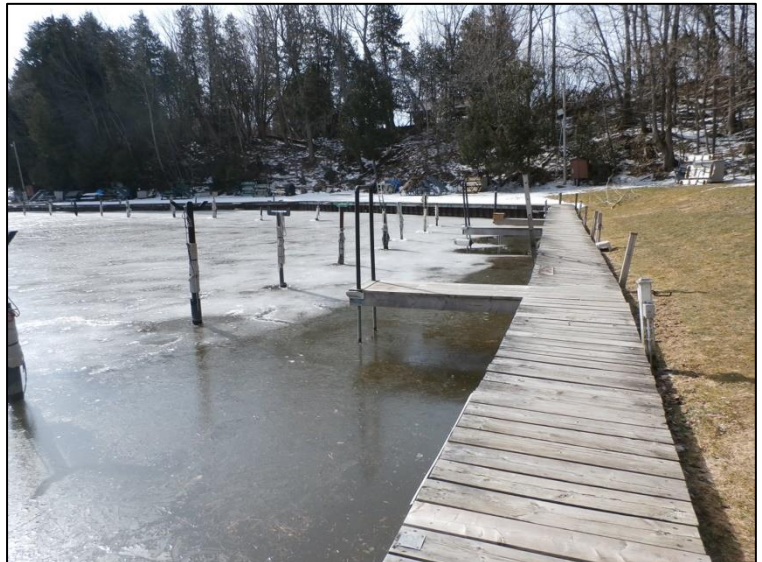
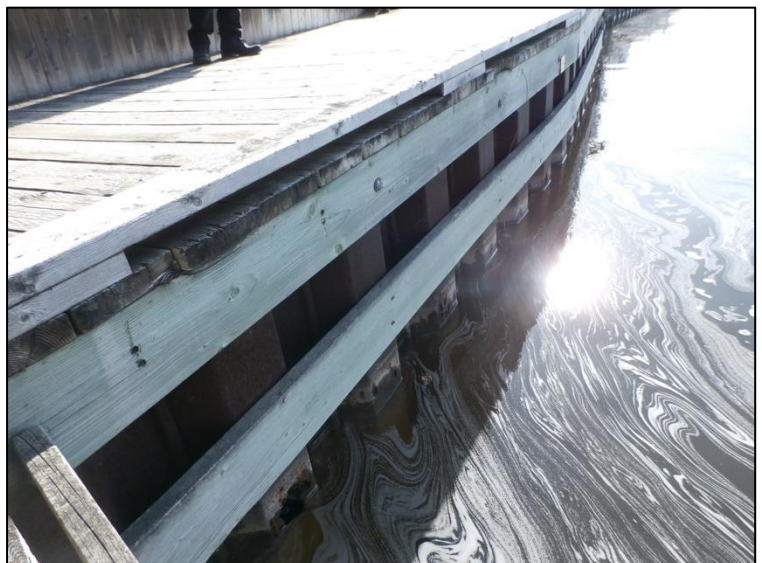
Image No. 5 and 6

Subject to the limitations of this study, the steel structural elements, the wooden deck and the railing appear to be in satisfactory condition. Periodic inspections are recommended.

General overview of the marina deck. It is supported by a steel support system

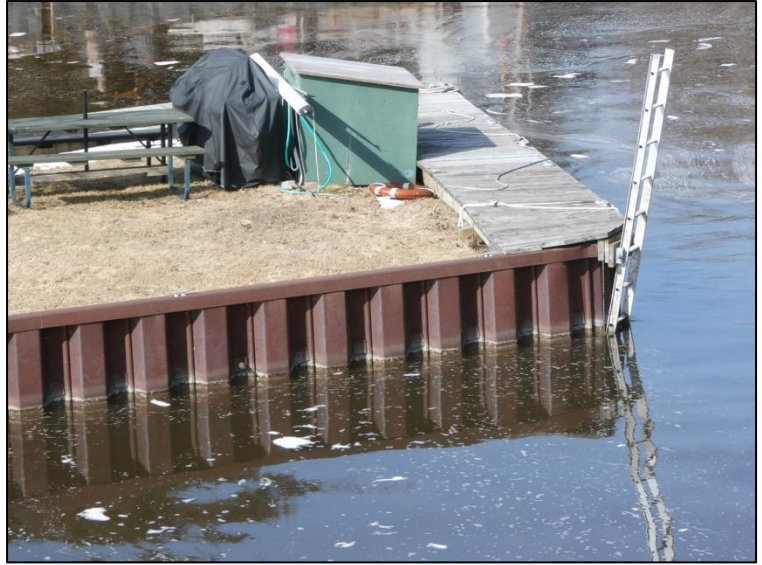
Image No. 7

Rust and local deterioration were observed at some sections of the steel break walls; however, subject to the limitations of this study, the overall condition of the marina is in a satisfactory condition. Local repairs assumed to be sufficient at this stage; however, further monitoring and periodic inspections are recommended.

Steel break wall that is also part of the marina's support system

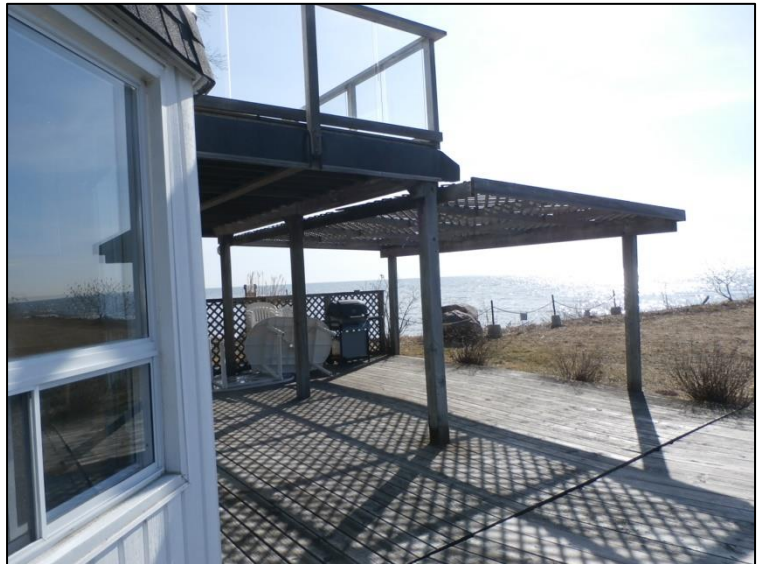
Image No. 8

A wooden patio deck is located at the rear of the house. The patio is sheltered by a wooden pergola that is attached to the wooden balcony. The pergola has a lattice and is supported by wooden beams. The current condition of the patio and pergola is fair.

Backyard patio deck with balcony and pergola

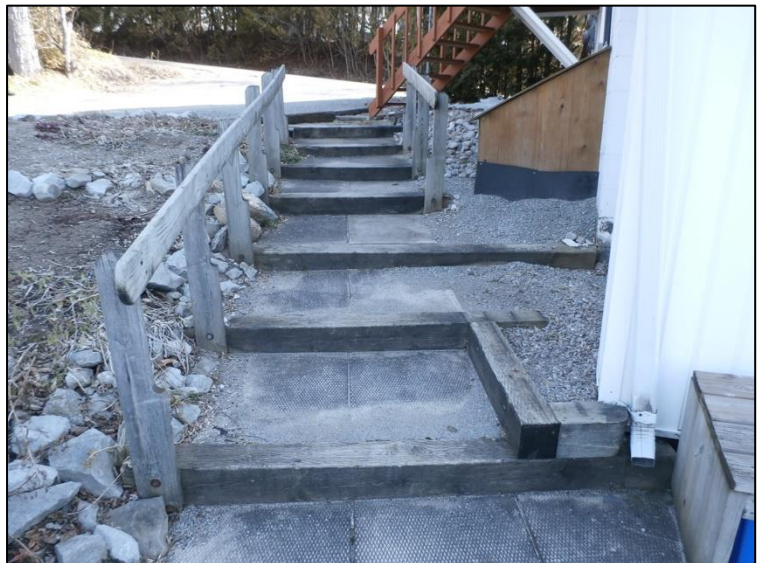
Image No. 9

The concrete pavers appear to be in good condition. Complete pavement replacement is rarely required; however, re-levelling and local repairs might be needed from time to time.

Stairs made of precast concrete pavers

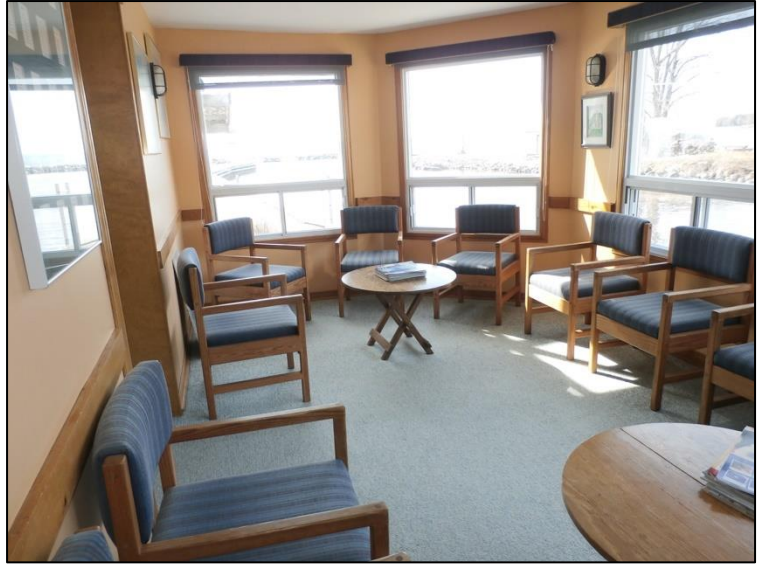
Image No. 10

General overview of the entrance lobby with carpet and associated furniture.

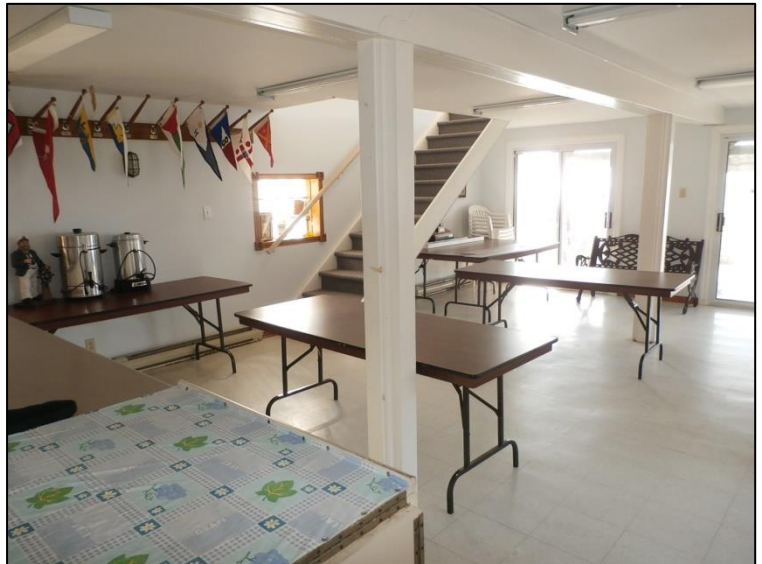
Image No. 11

The current flooring of the main floor of the club room is primarily vinyl flooring and carpeting, and ceramic flooring in the washroom and the entrance areas. The vinyl flooring and the carpeting will be replaced with laminated flooring.

Overview of the club room

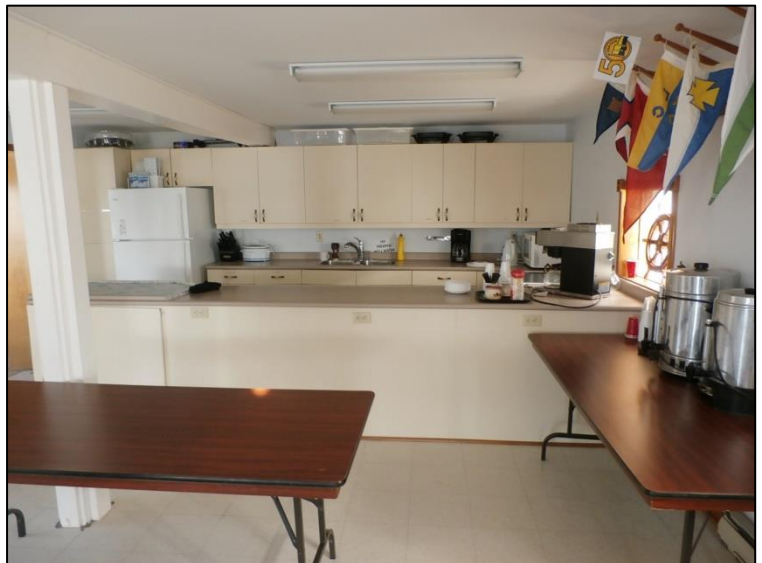
Image No. 12

The washroom is in good condition; it was renovated approximately 10 years ago together with the apartment. The kitchen includes a few appliances: a refrigerator, a range, a microwave oven, and coffee machines. The kitchen cabinets are obsolete, but in functioning condition.

Kitchen in the club room area

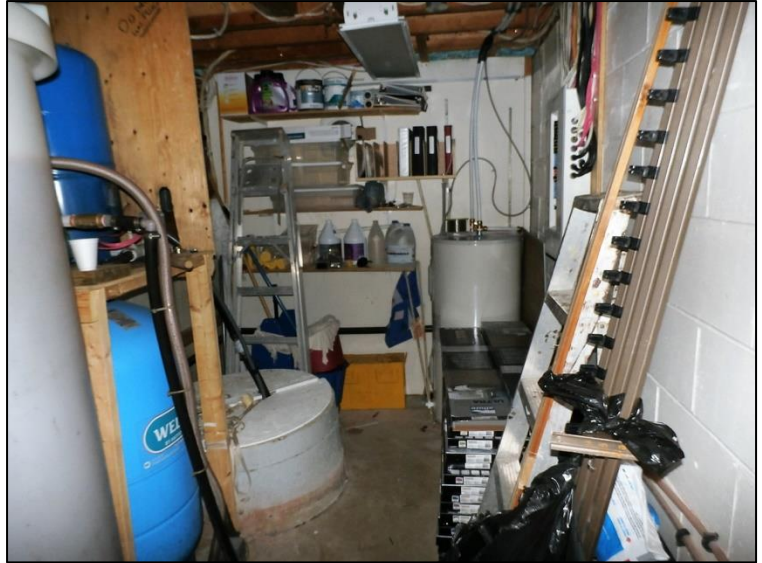
Image No. 13

General overview of the mechanical room

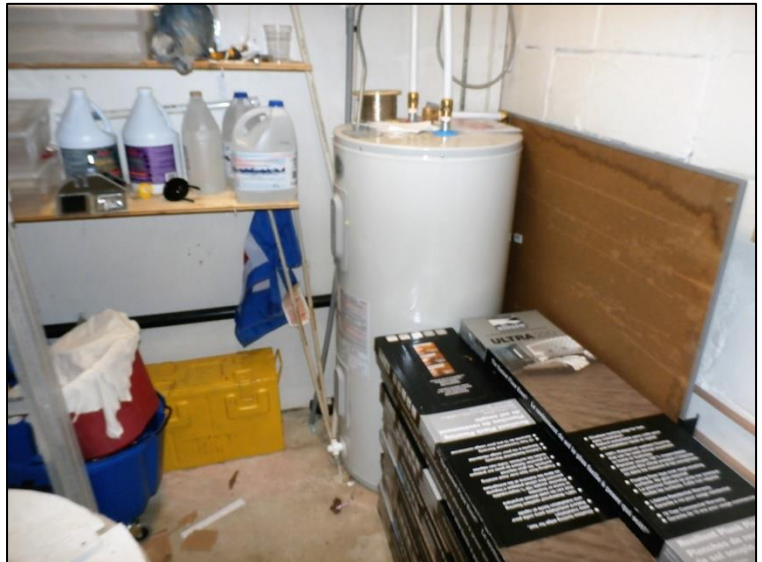
Image No. 14

Electric hot water tank

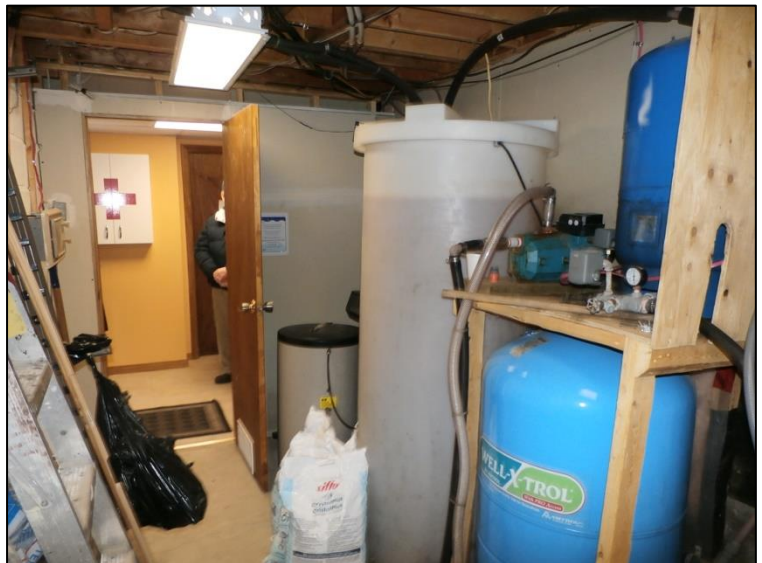
Image No. 15

Water filtration system that is connected to the water well. The cylindrical contains is part of the treatment system.

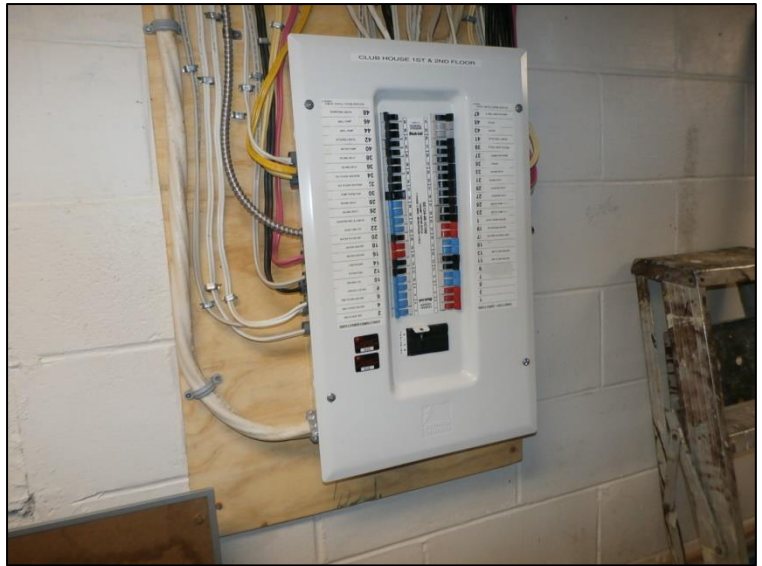
Image No. 16

The electrical system of the house includes a network of electrical wires and a circuit breaker panel. The life expectancy of the different components varies: some elements, such as the wiring, can last throughout the entire life of the building, while other components, such as circuit breakers wear more rapidly and require periodic replacement or repairs.

Circuit breaker panel for the clubhouse. A separate one provides power to the apartment floor.

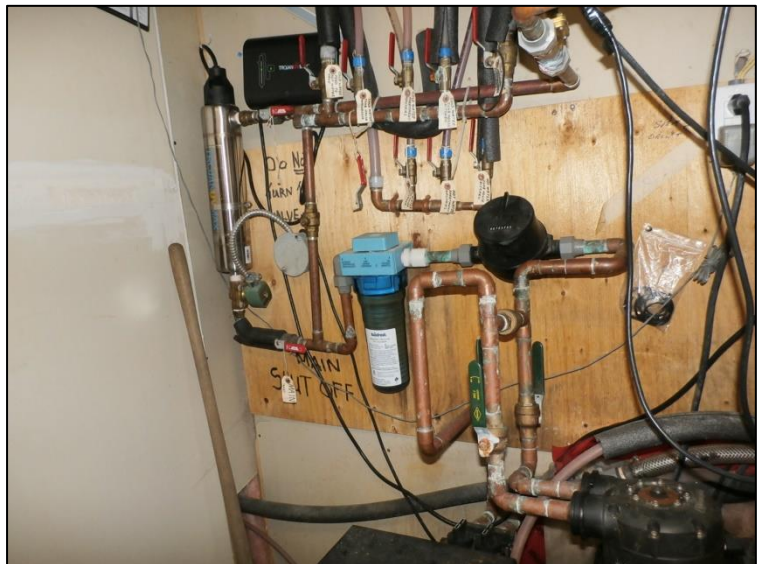
Image No. 17

The water supply pipes in the house are made of copper and appear to be of the original installation. No particular deficiencies or leakages have been reported. However, problems become more frequent as the system ages. Leakages and clogs may occur due to corrosion and failing valves.

Water supply piping that is connected to the municipal water system and the filtration system

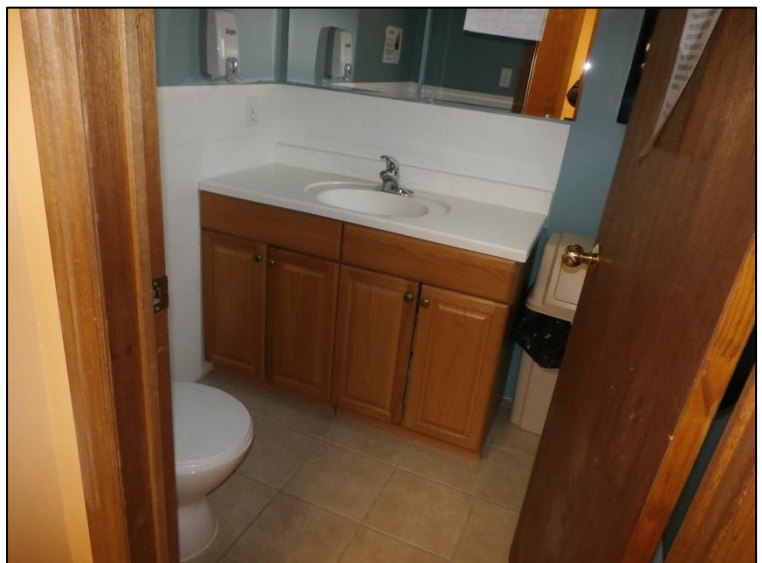
Image No. 18

Washroom on the clubhouse main floor

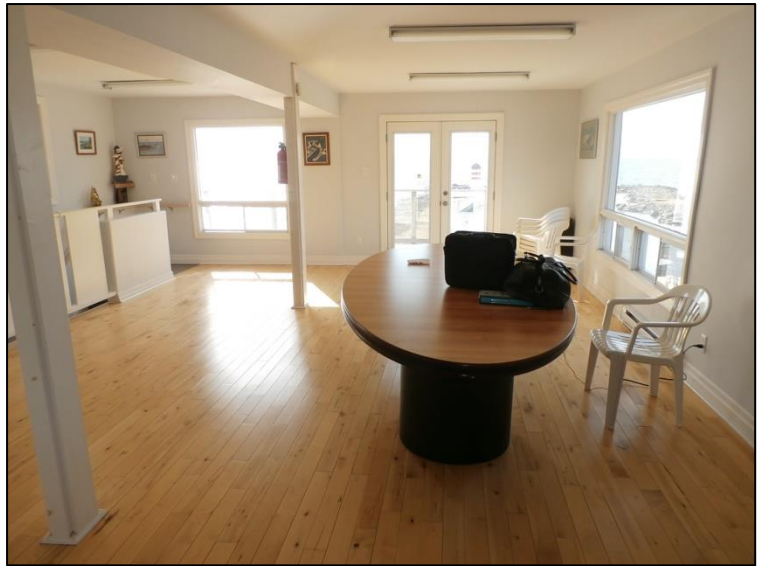
Image No. 19

General overview of the upper floor of the clubhouse

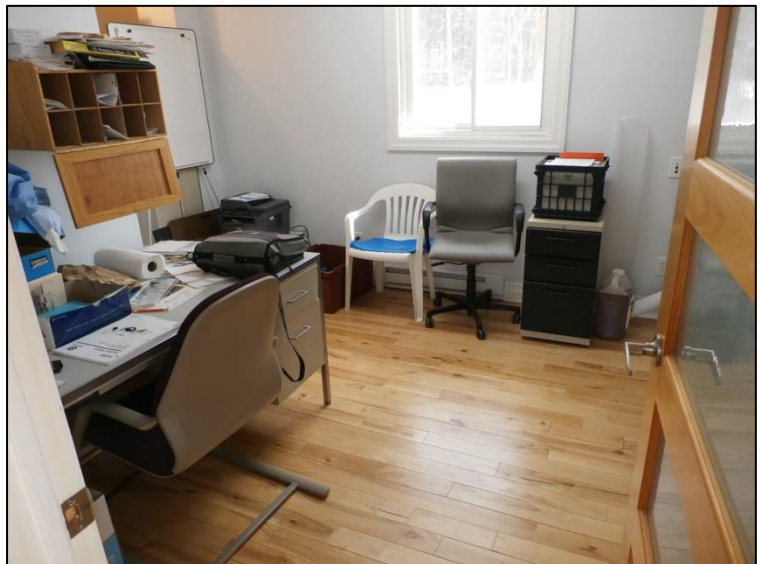
Image No. 20

Office room on the upper floor of the clubhouse

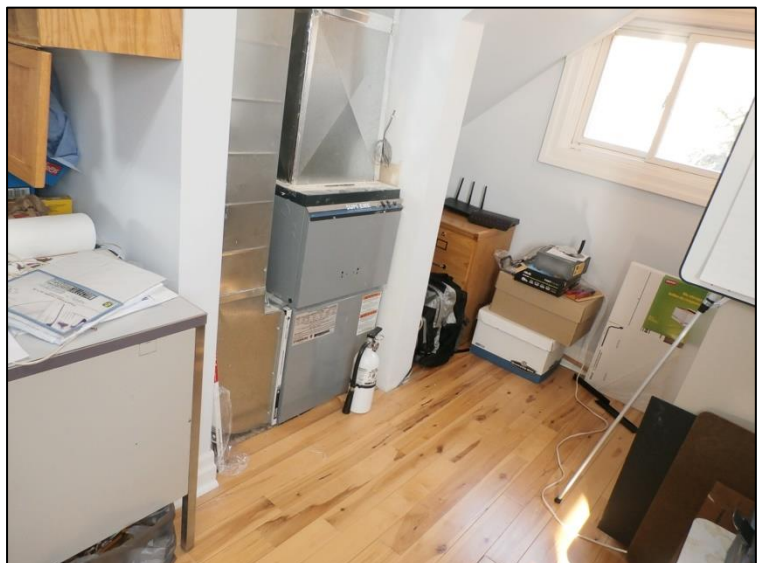
Image No. 21

A gas-fired furnace installed in the house

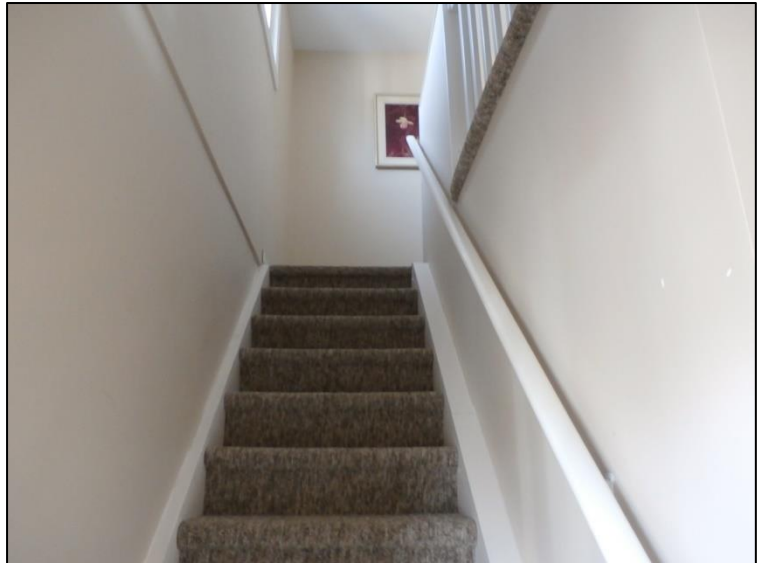
Image No. 22

Timber steps with wooden handrails are located at the side entrance (north side) of the house leading to the residential apartment. The stairs appear to be of the original construction and are generally in fair condition; however, the paint on the steps appears to be worn.

Stairs to residential apartment accessed from the side entrance of the house

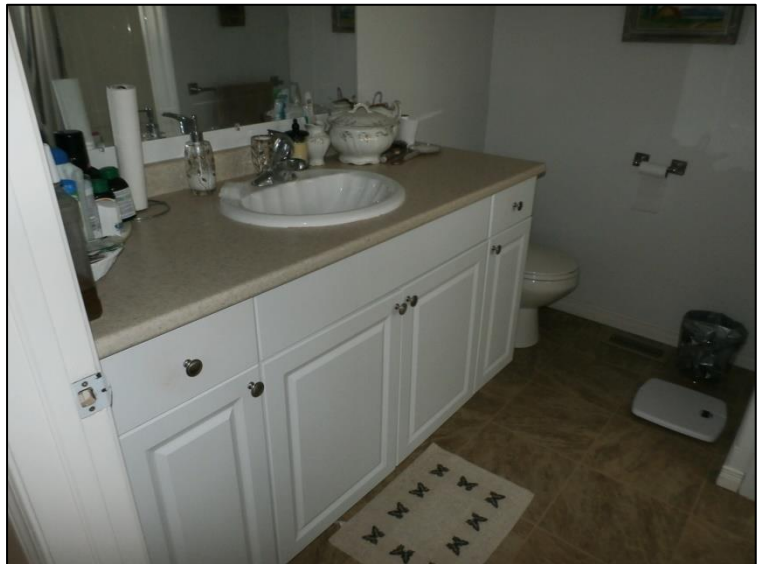
Image No. 23

Washroom of the residential apartment

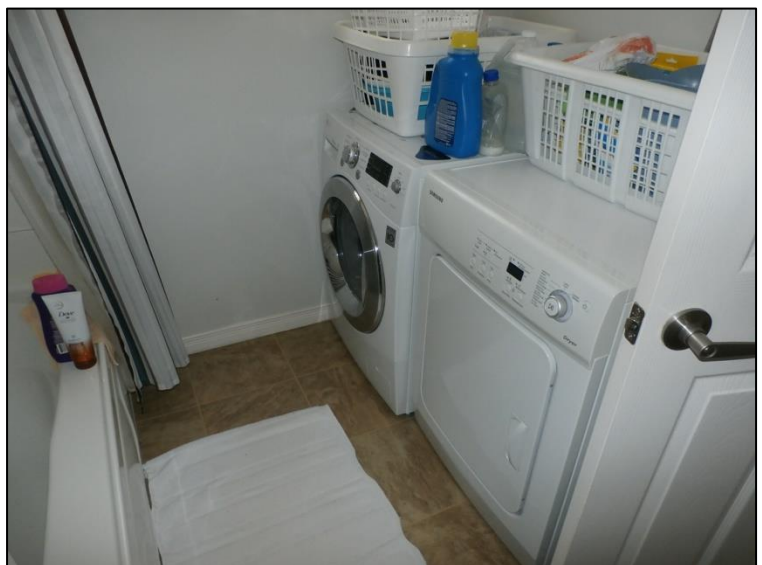
Image No. 24

Laundry room of the residential apartment

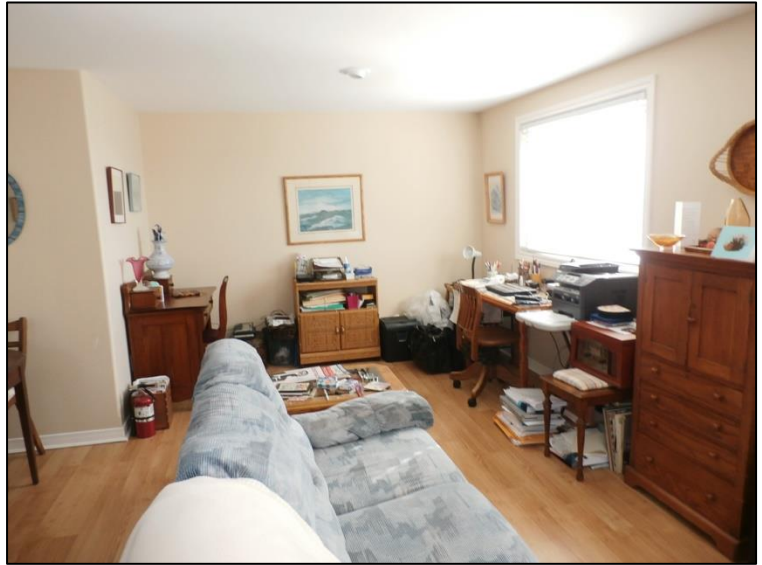
Image No. 25

The finishes of the apartment include hardwood flooring, painted walls and ceilings, all of which appear to be in good condition. The appliances include laundry dryer and washer, refrigerator, range and a dishwasher.

Living room area of the residential apartment

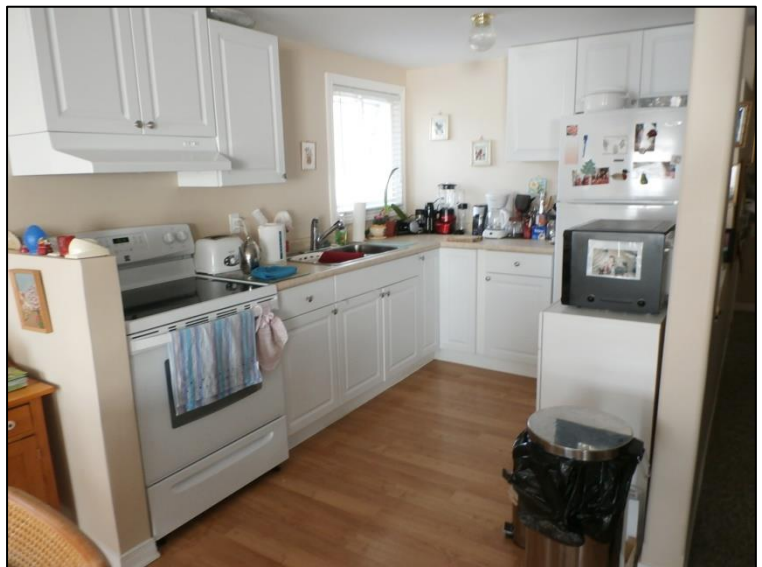
Image No. 26

Kitchen of the residential apartment

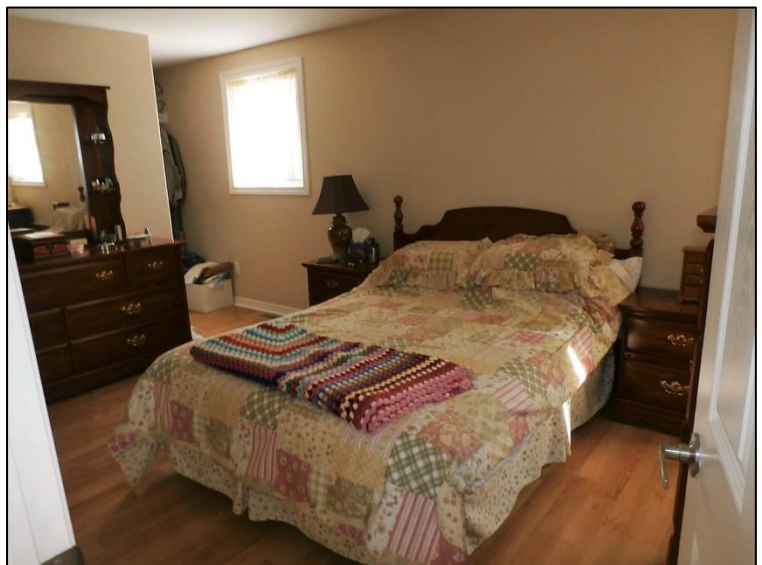
Image No. 27

Bedroom of the residential apartment

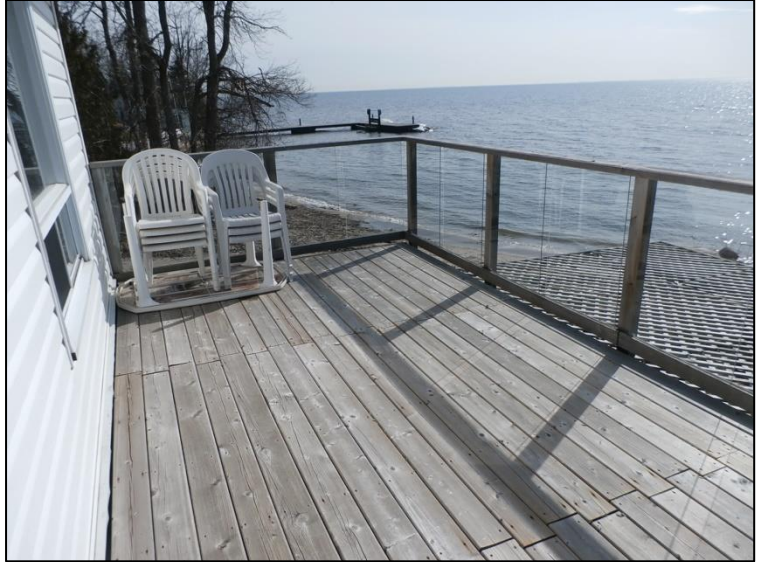
Image No. 28

There is a pressure-treated wood balcony located on the rear side of the house's upper floor. The balcony appears to be in fair condition; no significant deficiencies were reported or observed at the time of the site inspection. However, it should be noted that the actual structural condition cannot be inspected and is beyond the scope of this report.

Wooden guardrails with vertical wooden poles, glass panels and wooden top railing are installed along the balcony edges. The current condition is fair.

Overview of the wooden balcony with guardrails and pergola

An allowance has been made for local repairs at 20-year intervals for major rehabilitation work, including replacement or repair of damaged components. In addition, periodic staining is required to minimise the deterioration pace.

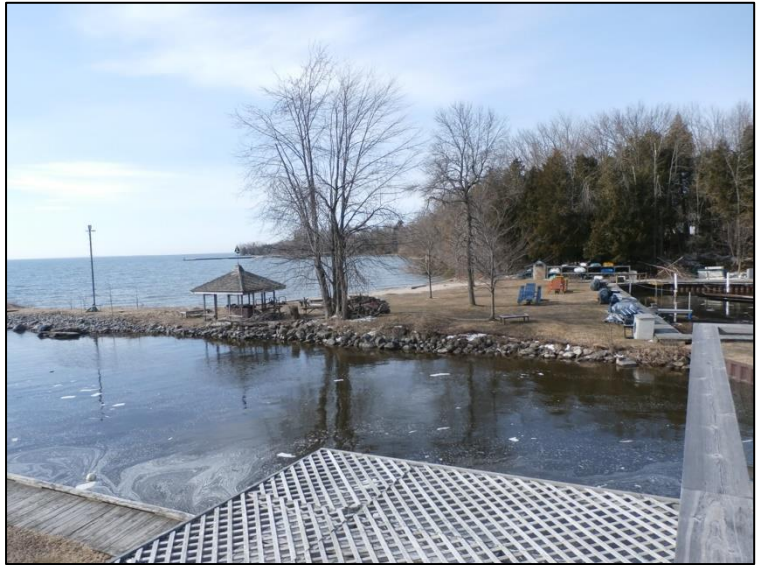
Image No. 29

General overview of the beach area of the site

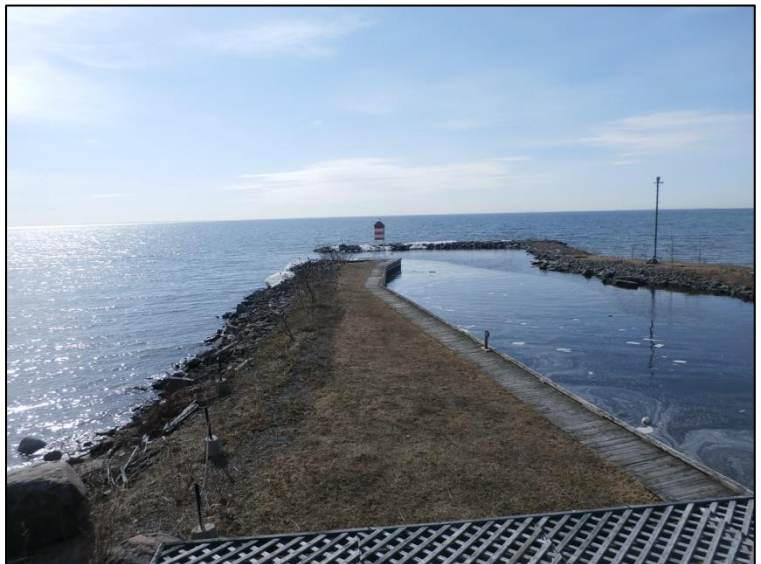
Image No.30

A small steel-framed lighthouse with an electrical light beacon is located at the southern end of the property and faces Lake Simcoe in order to mark the shoreline. An additional steel mast with a light beacon is located in the beach area. Both light beacons appear to be in good condition.

Southern boundary of the site facing Lake Simcoe. The lighthouse and beacon are located here.

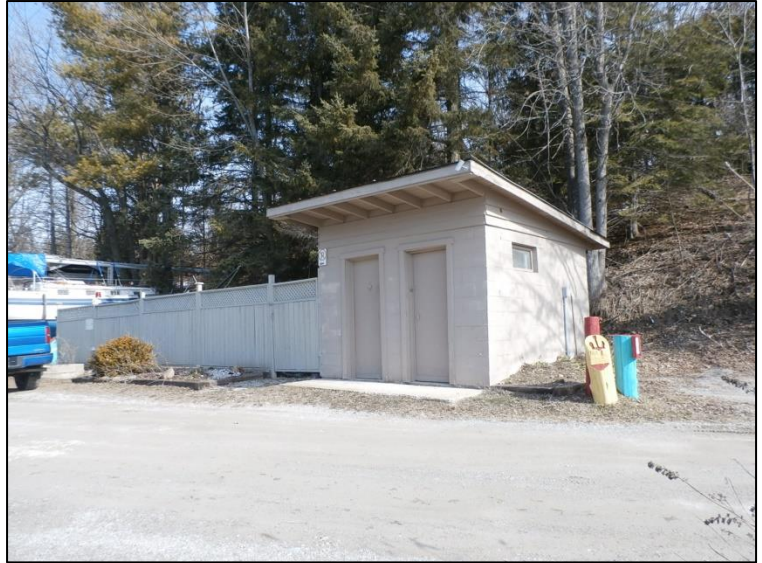
Image No. 31

The roof is in poor to fair condition; the roof's steel sheets are rusty, the wood is cracked and a downspout at the back is missing.

General overview of the storage building

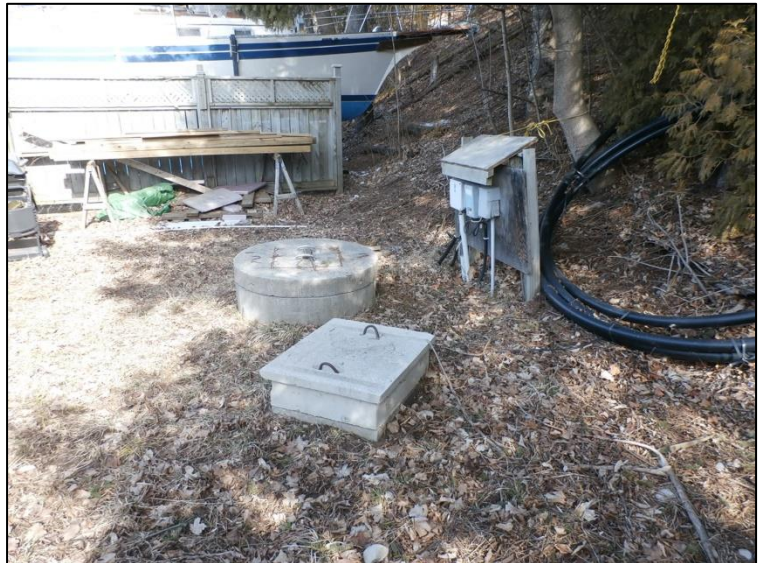
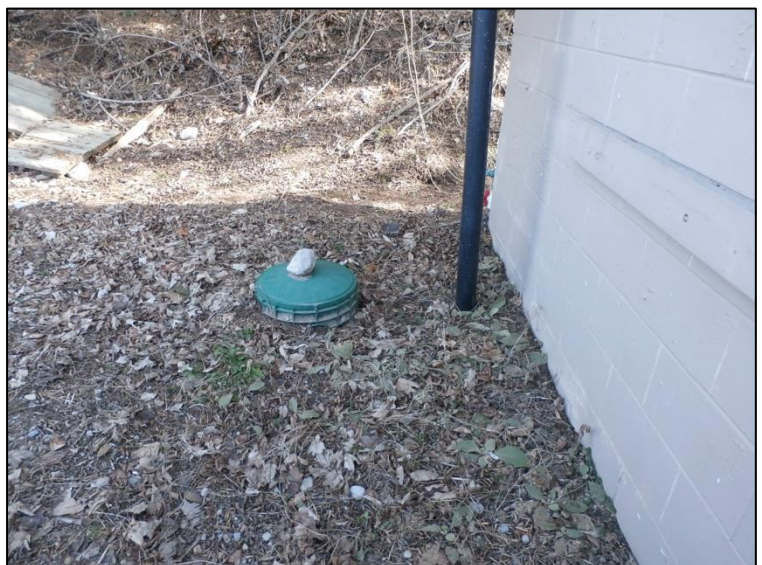
Images No. 32 and 33

Elements of the septic system on the north side of the storage structure

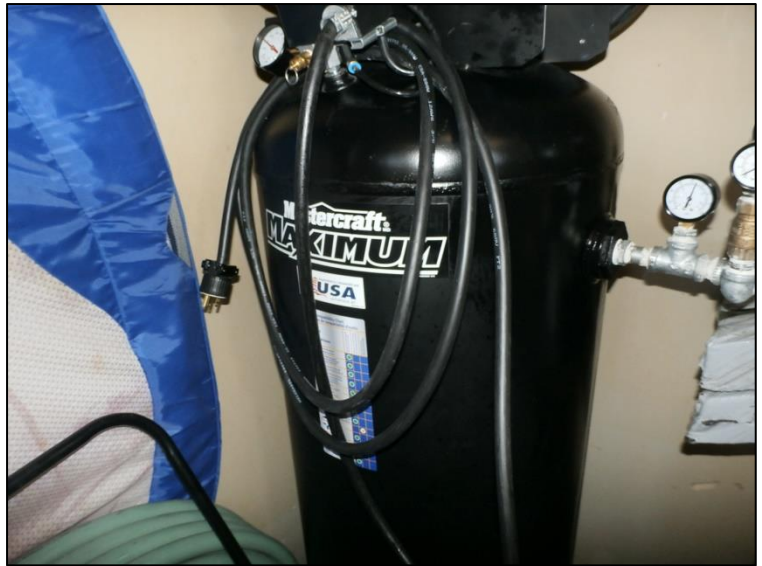
Image No. 34

Compressor tank inside the storage building

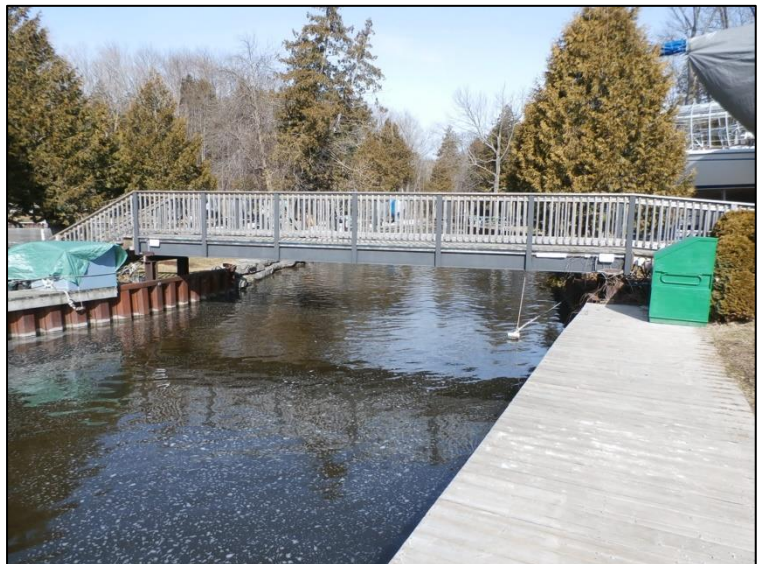
Image No. 35

The pedestrian steel bridge

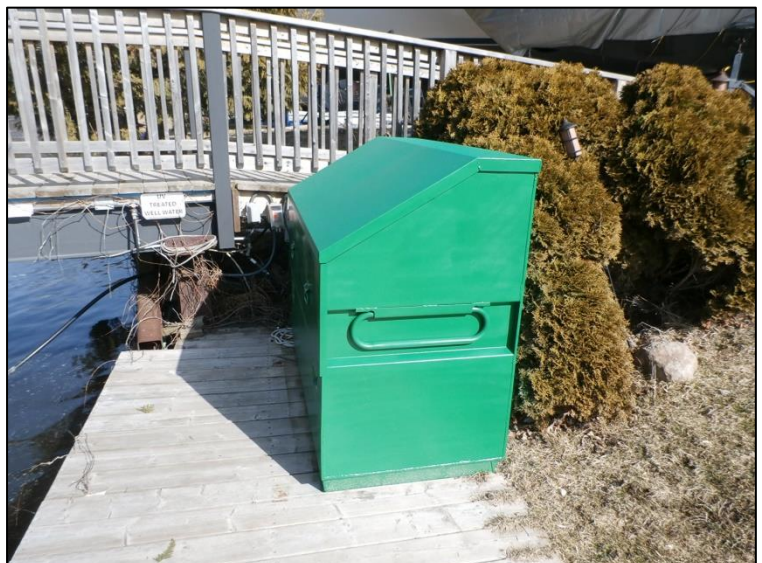
Image No. 36

Green marine pump-out system used for extracting water from the lake. The water is then filtered and used for washing the boats.

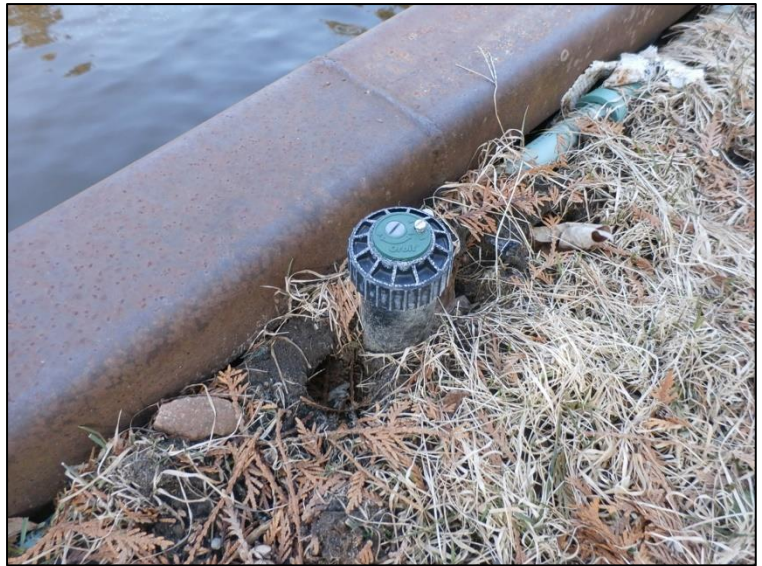
Image No. 37

Irrigation system

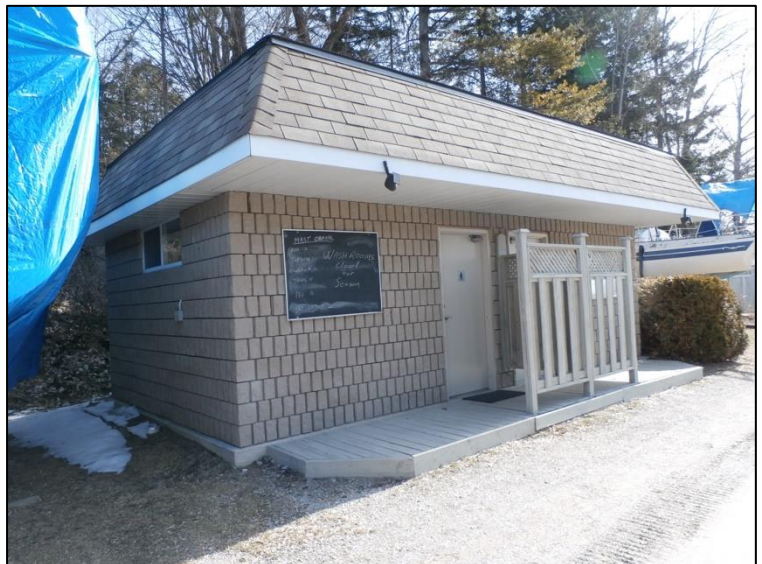
Image No. 38

The washroom structure has a pitched wood framed roof with asphalt shingles with aluminum soffit. The roof shingles and the soffit appear to be in good condition. The roof's wood components are part of the building's structure and will unlikely need replacement during the lifetime of the building.

General overview of the washrooms building

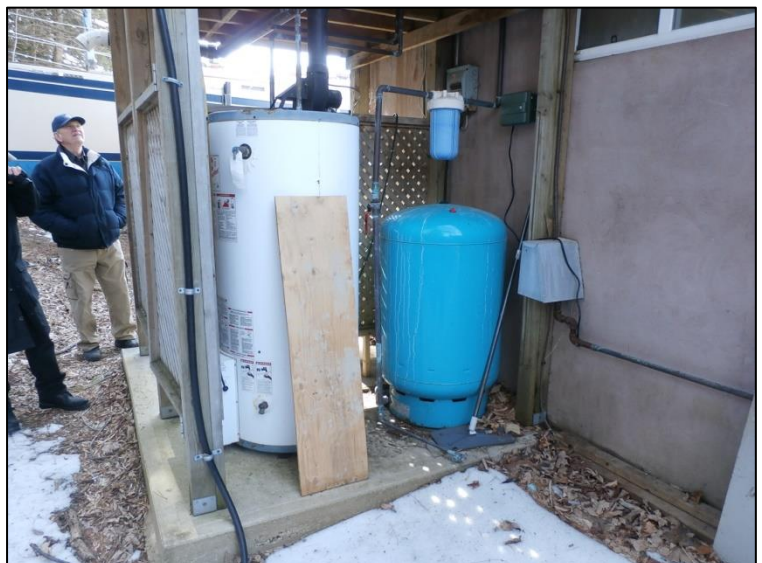
Image No. 39

Gas-fired hot water boiler and filtration system at the rear of the washrooms structure.

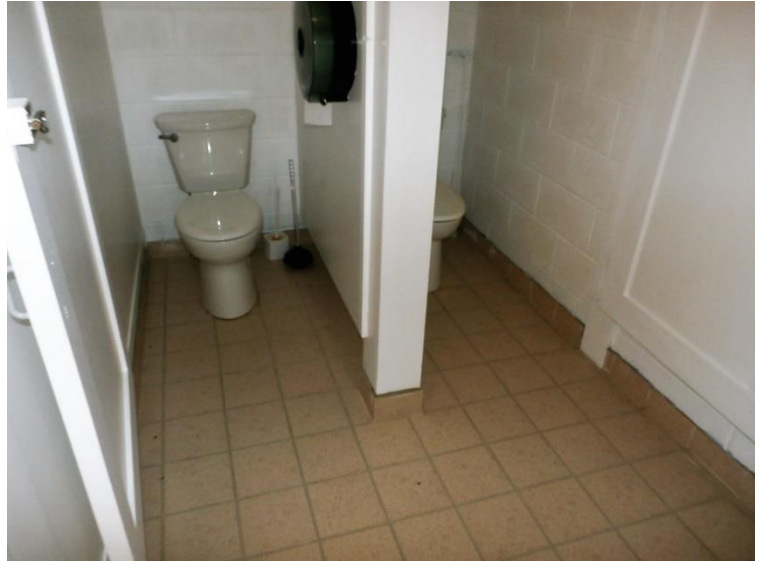
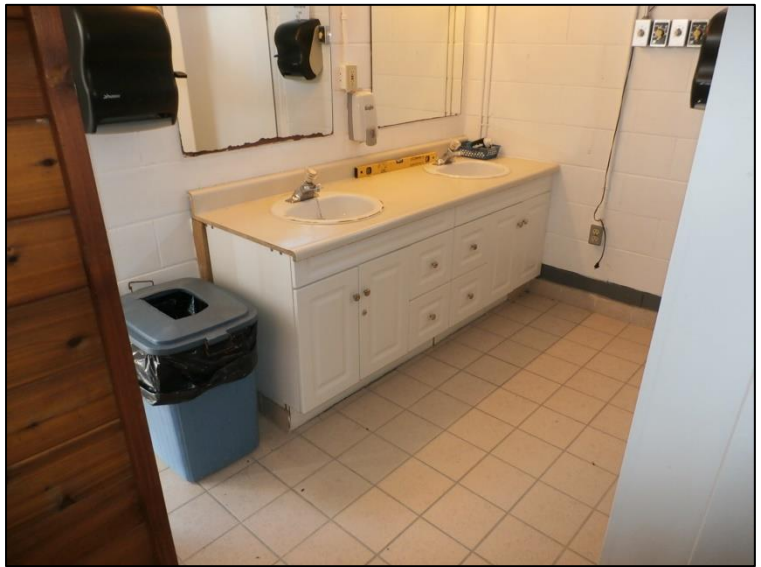
Images No. 40 to 41

General overview of the interior of the washrooms structure.

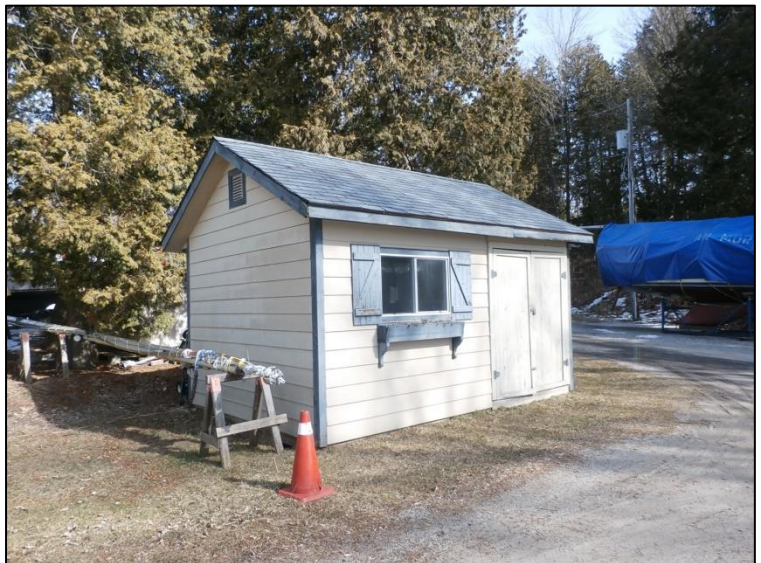
Image No. 42

One of the storage sheds at the site

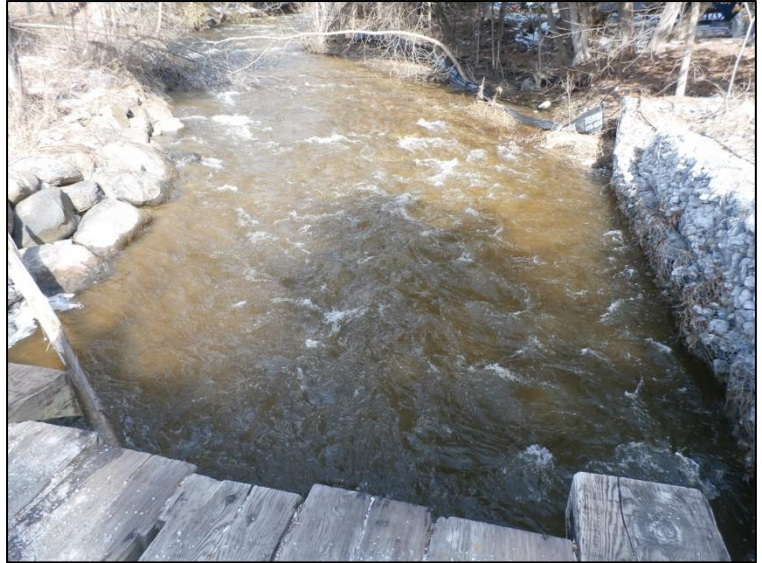
Image No. 43

Stone breakwalls are located as break walls facing the lake and the creek as armouring to protect the banks from erosion. Some of the stone breakwalls have metal wiring (gabions) to prevent stones from loosening.

The current condition is good. It is unlikely that complete replacement will be required, but, local repairs could be required from time to time.

The creek with stone break walls used for armouring the banks.

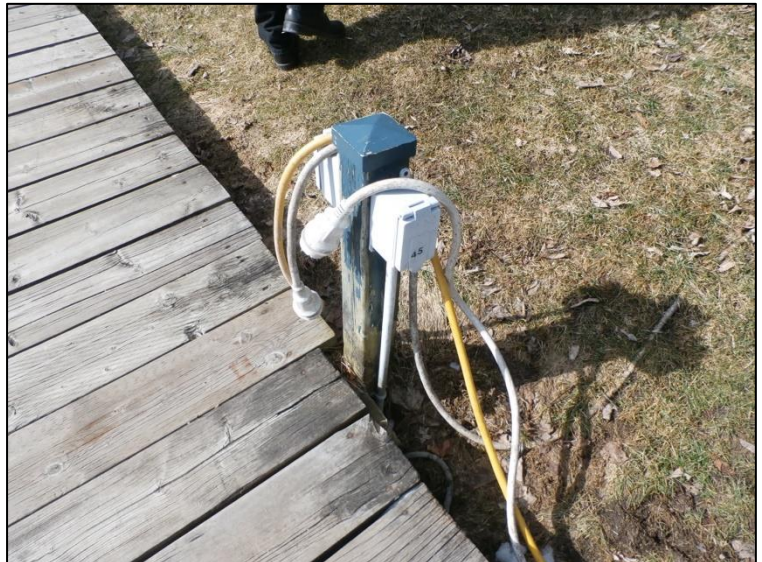
Image No. 44

One of the several electrical outlets throughout the marina deck for the boats.

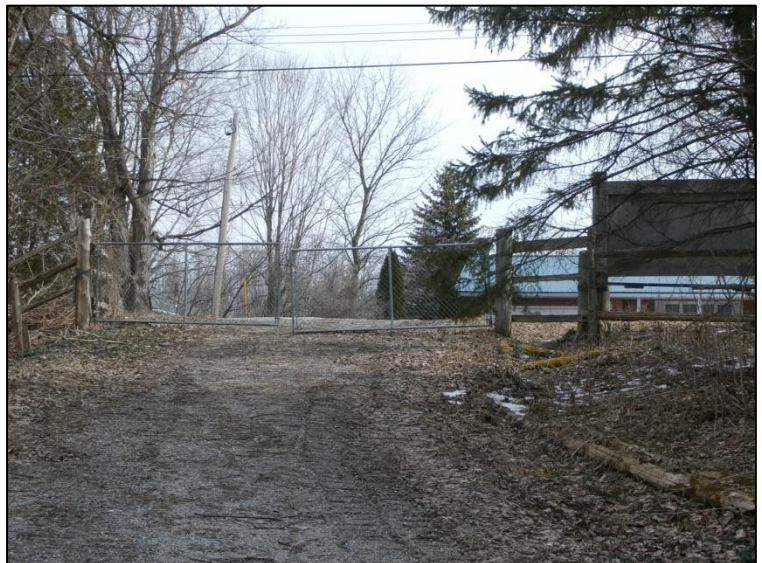
Image No. 45

The current condition of these gates is fair; however, the gates appear to be leaning and may need to be levelled.

Northern entrance to the property. The gate consists of two chain link fences and wooden country fences.

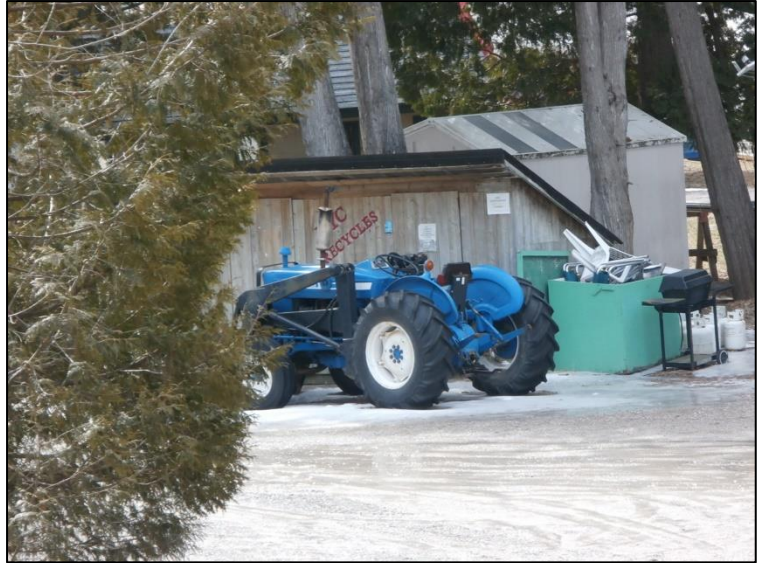
Image No. 46

The site's tractor

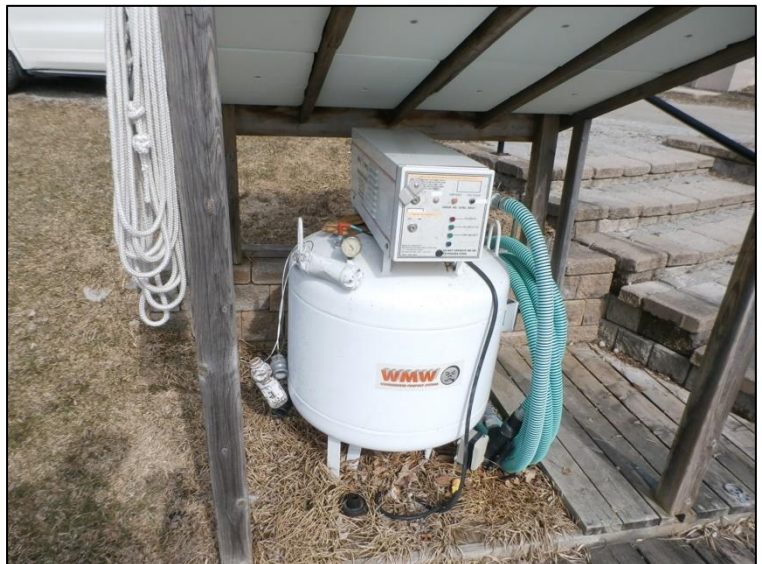
Image No. 47

One of the marine pump-out systems used for water extracted from the lake.
